**Project Title: Monaleen Church Limerick**

**Document Title: Church Tower Water  
ingress**

**101184-PUNCH-XX-XX-RP-S-001**

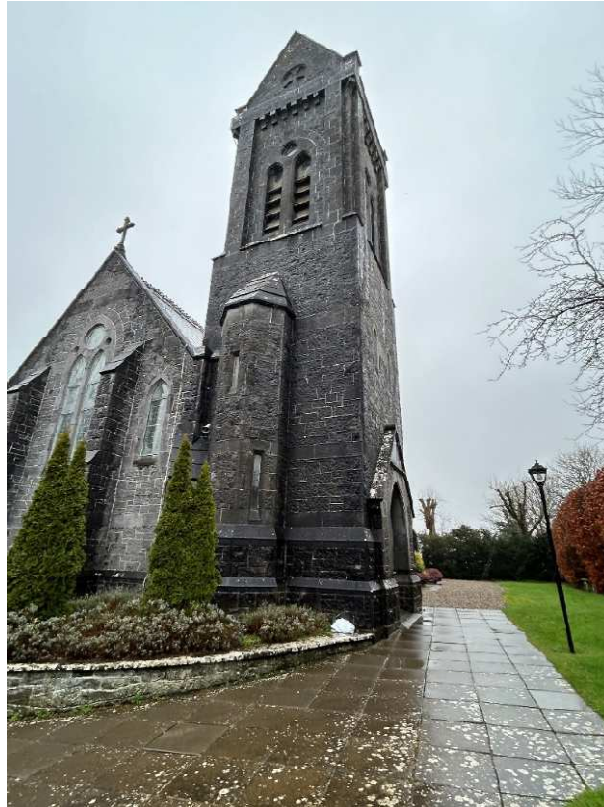
Photograph 001 Showing the external saturated Bell Tower.

Preliminary review of the bell tower indicates that the tower, from the bell louvers down to the ground was repointed some years ago using a cementitious mortar or a very strong pointing mortar that does not now allow the ingress water to egress the masonry structure via the mortar pointing. Mortar pointing if done properly in these type of masonry structures is a sacrificial pointing which allows ingress water to egress via the joint mortar such as a lime mortar, the erosion of the mortar pointing indicates egress of moisture through the mortar pointing, but in this case this is not happening, therefore the moisture is being held within the masonry structure & penetrating into the internal face of the bell tower wall.

The mortar in the masonry joints should be removed & the masonry re-pointed using the appropriate lime mortar mix to allow the water to egress from the structure via the mortar joints including copper weep holes if deemed necessary.

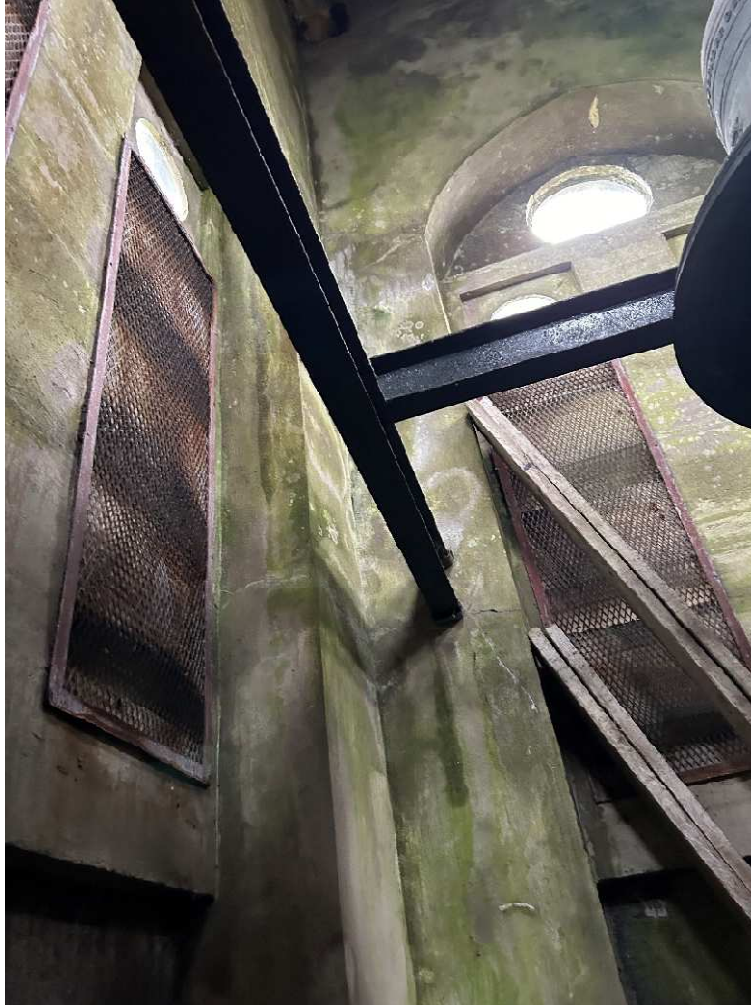
Photograph 003 Showing internal photograph of the Bell Tower at the bell level, water ingress on wall walls noticed on the internal plaster.

Dehumidifiers can be placed in the bell tower to extract moisture once the mortar joints have been re-pointed in a breathable lime mortar & natural drying out has taken place.

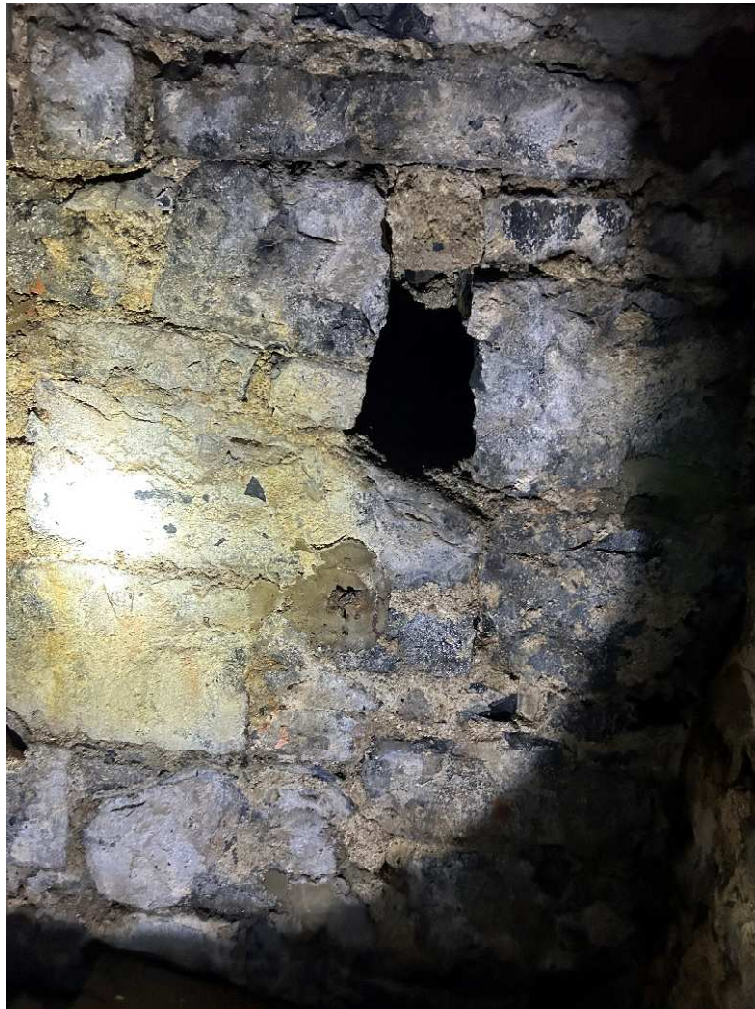
Photograph 004 Showing internal photograph of the Bell Tower lower level at exposed random rubble stone walls, all face of the exposed stone are wet & some having dripping water for surface water.
